Heavy rapid impact compaction for transportation of 13500 ton railway bridge in Muiderberg, the Netherlands

J. Vink, J.W. Dijkstra

Cofra B.V., Amsterdam, the Netherlands

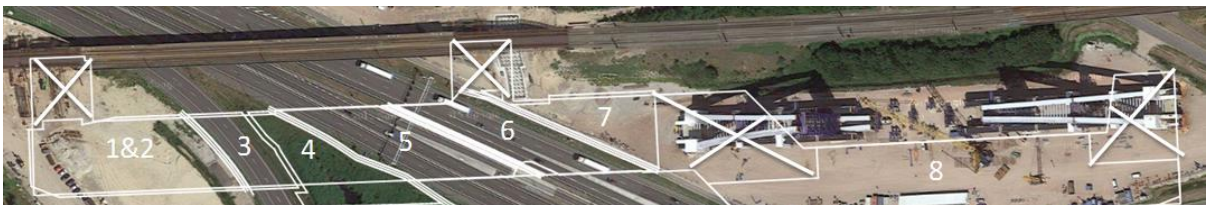
Figure 1 - Overview: A1 highway, planned carriageway (white borders) and temporary bridge location

After partial completion, the bridge was transported using two 500m² groups of Self Propelled Modular Transporters (SPMT's) over a length of 380m to a temporary foundation next to old bridge where the concrete deck and railway infrastructure was added. From this position, the bridge was horizontally jacked to its permanent position to become part of the existing railway track. Figure 1 provides a top view of the

construction site, the transport route and final position of the bridge.

- A soil profile with 1 to 2m of peat (part 1, 2 and 4 of figure 1)
- A soil profile with approx. 0.5-1.5m of peat with a partial soil replacement of sand on top (part 7 and 8 of figure 1)
- A soil Profile without any peat but with a loose sand layer (underneath the highway in part 3, 5 and 6 of figure 1).

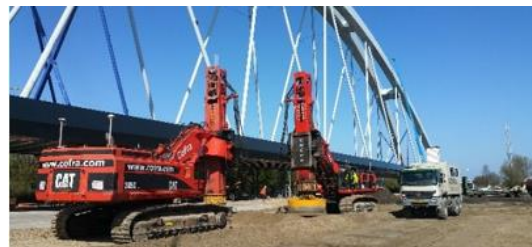
Figure 4 – Compaction operations next to the temporary bridge location

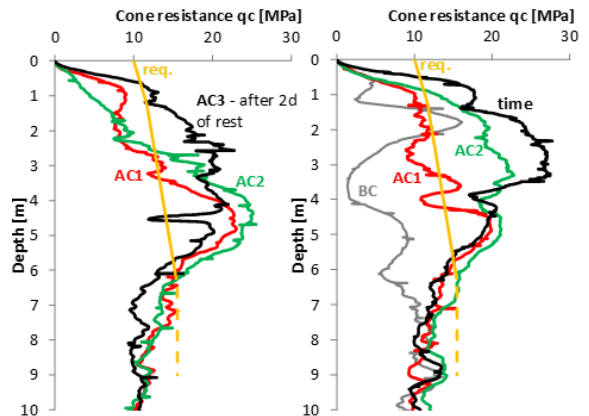
The compaction induced excess pore pressures in the sand influenced CPT cone tip resistance results in case the CPT was performed shortly after compaction, predominantly in areas where a very recent soil replacement was performed. Especially in the top layer the requirements were sometimes not directly reached even after 2 or 3 compaction passes (even with the PVD's in place). An example is given on figure 8 (left) which illustrates the CPT results just after the first (AC1), the second (AC2) and even a third pass (AC3) with CDC – represented by the red, the green and the black line respectively. As can be observed from the graph there is little to no improvement in the top 4m. During these CPT tests the water was still flowing up through the surface and vertical drains, clearly indicating excess pore water pressures. The graph also shows a test nearby that was performed after another compaction pass and a resting period of approx. 2 days, clearly showing an increase in of 5-10Mpa in the top layer which is caused by the dissipation of water pressures.

Figure 8 – Left: CPT results just after soil replacement and compaction and after a period of rest, right: typical average cone resistance before and after compaction (2nd pass) in Area 1/2

Figure 8 (right) shows an example of a typical CPT with the average CPT cone resistance before (BC) and after compaction (AC1 & AC2) in area

1/2 (figure 1). As can be observed the influence depth of compaction, i.e. the depth where a cone resistance increase visible, is around 7.5-8m with a significant increase of cone resistance in the top 6m. There is also clearly a significant increase of cone resistance in the top 4m of the CPT's taken after a rest period of approx. 30d. Over this relatively short time span it is expected to be caused mainly by the further dissipation of excess pore water pressures and possibly some slight aging effects (chemical bonding).

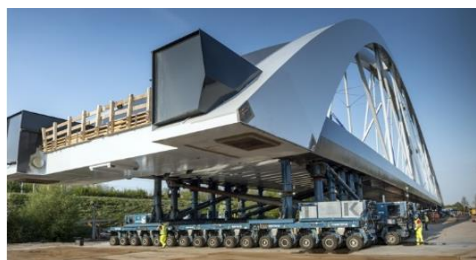
Figure 9 – Bridge just before transportation

The extensive preparations and use of one central control room and live link to the operator paid off during the whole operation. The CDC compacted runway showed a dilatant behavior, which allowed for a 3 hour faster bridge transport than its earliest anticipated arrival.
